IMPLANT RESTORATIONS MAINTENANCE

Metodi Abadzhiev
Prosthodontic Department, Faculty of Dental Medicine,
Medical University - Varna

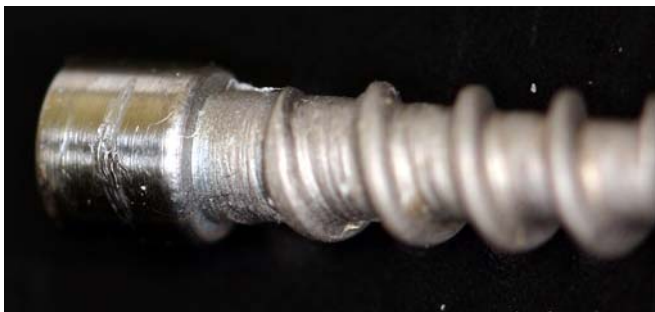
Fig. 1. The damaged titanium implant surface, exaggerates the holding plaque

This guide to more plaque retention.

A gum inflammation around the implant that is harmless at first sight and may even run without clinical symptoms, can lead to crestal resorption. This calls for a regular professional maintenance, ensuring the successful functional life of the implants. But the conventional ultrasonic tips are aggressive and they can harm implant's surface at cervical area.

The plaque indices are lower in the regularly examined patients. The number of periimplant inflammations also. The implant surface's damage after standard ultrasonic tip using is clearly demonstrated on pictures and electron-microscopy images.

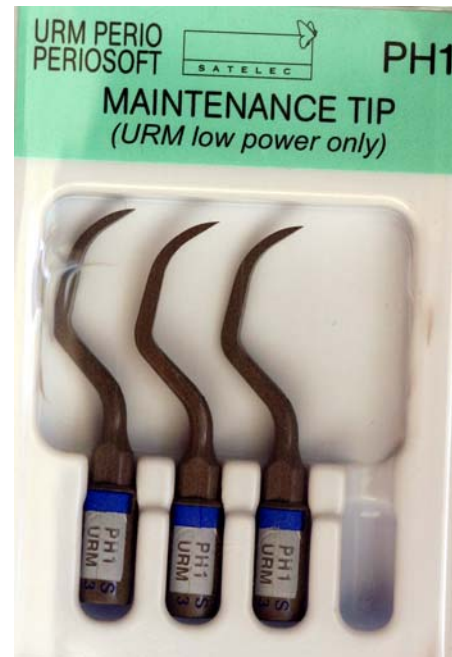
Fig. 2. Satelec teflon tips.

Statistically significant number of patients with implant suprastructures. 78 patients with 109 prosthetic restorations over implants (91 fixed and 18 removable restorations, 3 to 5 years old), were examined for 7 days. Plaque indices were used for evaluation of the oral hygiene level. 29 of these patients have visited the practice twice a year, 34 once a year, 10 – only once after the treatment was completed, and 2 of them haven't visited us after the placement of the restorations. Ultrasonic unit with carbon and teflon tips for implant maintenance.

The plaque index increase inevitably leads to periimplantitis. Recurrent oral hygiene procedures are obligatory and the suitable instruments are carbon and teflon tips.

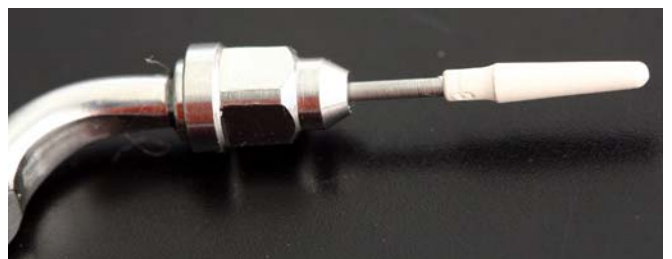
Fig. 3. EMS carbon tips.

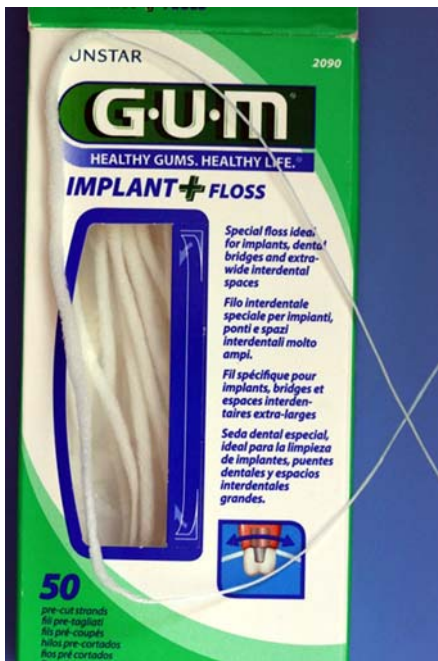
Fig. 4. Floss active for periimplant cleaning.

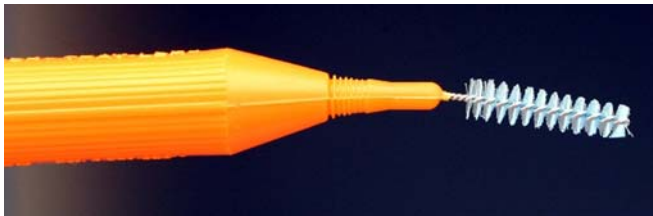
Fig. 5. Micro brush for cleaning the interimplant space.

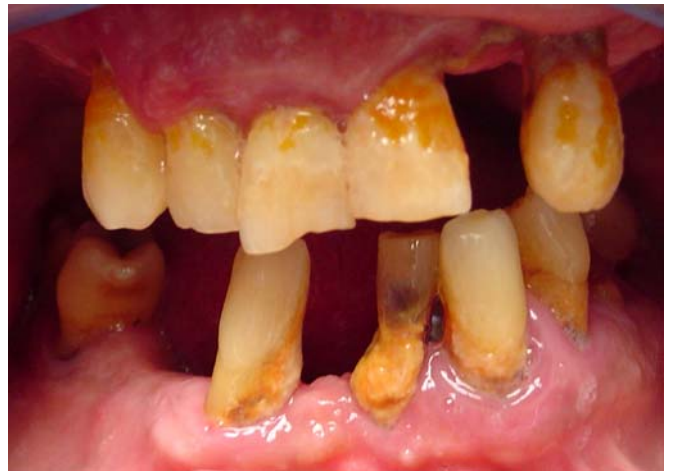
Fig. 6. Bad oral hygiene, temporally evidence for implant treatment.
